NUREG/CR-5141

Aging and Qualification Research on Solenoid Operated Valves

Prepared by V. P. Bacanskas, G. J. Toman, S. P. Carfagno

Franklin Research Center

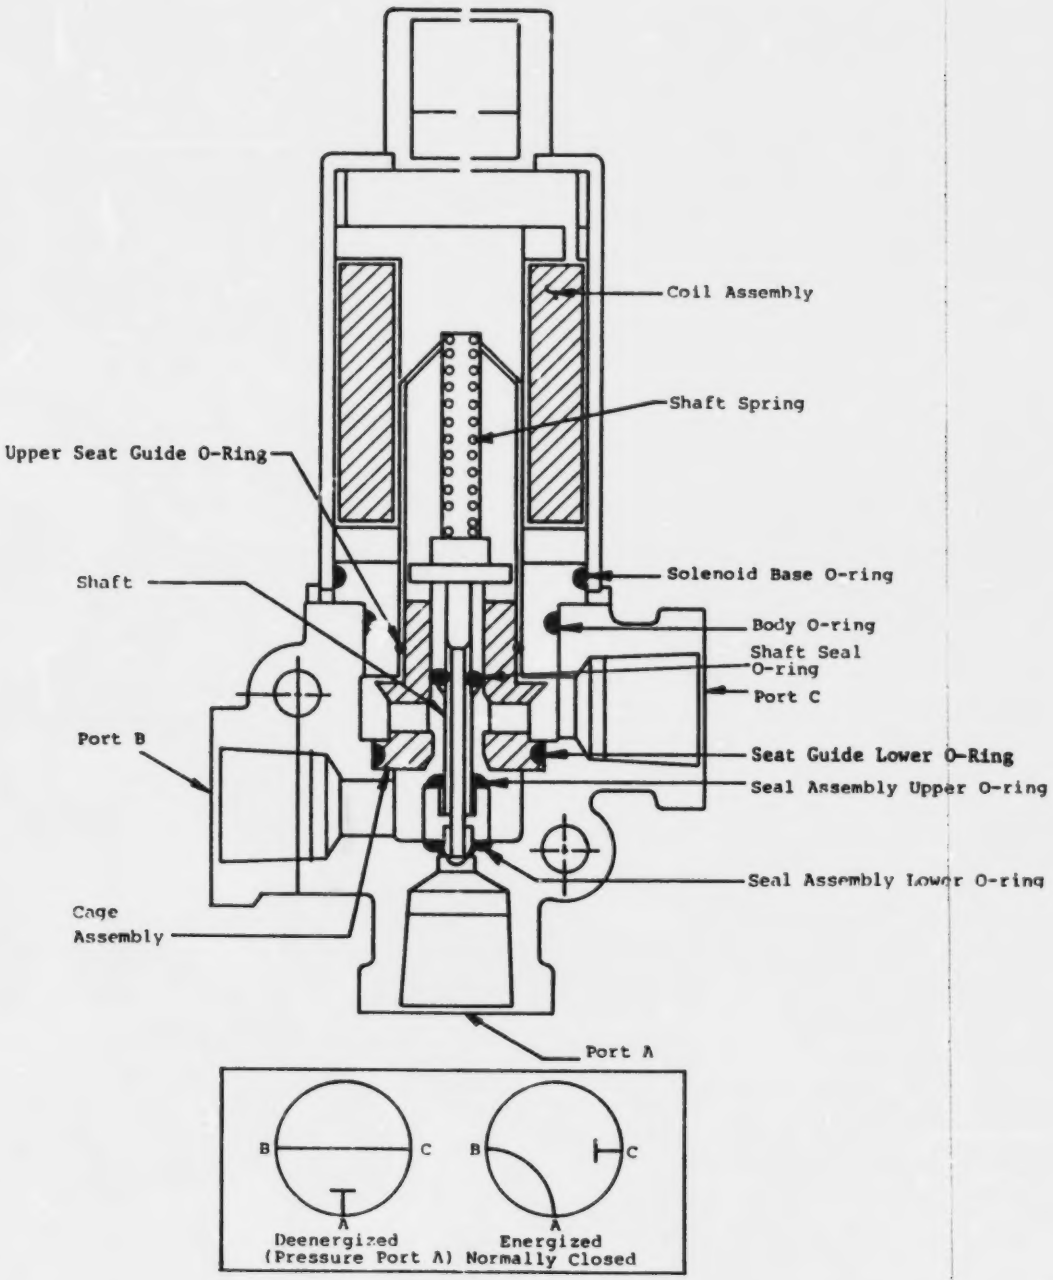
Figure 2. Section View of Valcor V-70900-21 SOV

Two of the three Valcor SOVs (6096-22 and -23) failed to return to their deenergized position upon deenergization of their coils. A failure analysis showed that the failure to transfer was caused by sticking of the shaft seal O-ring to its guide tube. Using a spare Valcor* SOV, the temperature of the shaft seal O-ring was measured as 278°F (137°C) at the thermal aging temperature of 230°F (110°C). The temperature measurement confirmed that the temperature at the shaft seal O-ring had not exceeded the manufacturer's suggested limit of 300°F (149°C).

No observable deterioration was noted in the coil or coil housing. The body gasket (see Figure 2) O-ring had taken a compression set, but had remained pliable and, based on the results of the functional test, was performing its function. A thin film of the material found in the ASCO NP8314 valves that stuck during aging was observed on the top of the core assembly where it meets the top of the solenoid base subassembly.

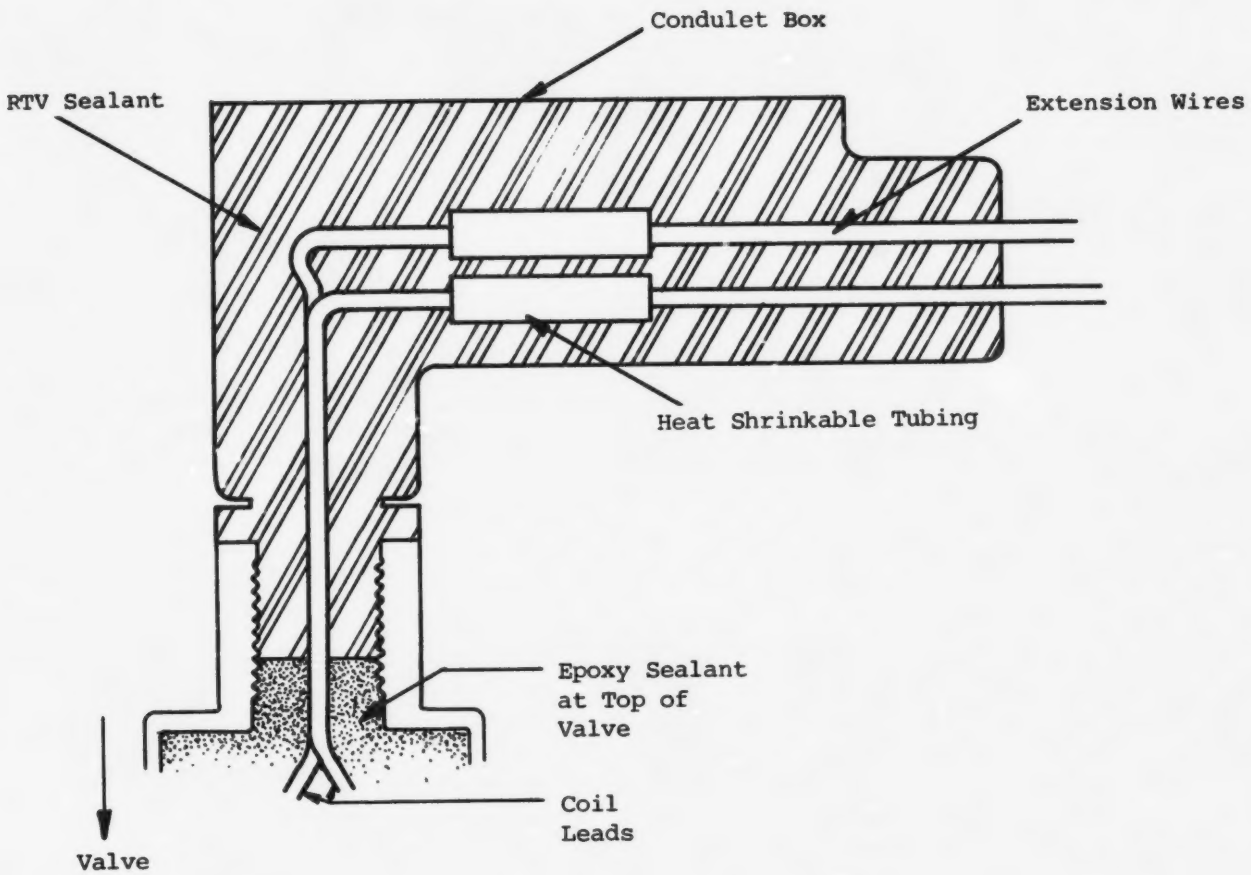
Figure 6. Electrical Interface Sealing Configuration

Prior to the MLSB/LOCA exposure, the solenoid leads were butt-spliced to Teflon-insulated solid conductor extension wires. The spliced sections were covered with Raychem Thermofit WCSF-N heat-shrinkable splices. A threaded condulet box was connected to the solenoid housing and the leads were routed through the condulet box. The condulet box cover was removed and a General Electric RTV silicone compound was poured into the condulet box, filling the condulet box from the solenoid housing (see Figure 6) to the condulet outlet. The removable cover was then replaced.

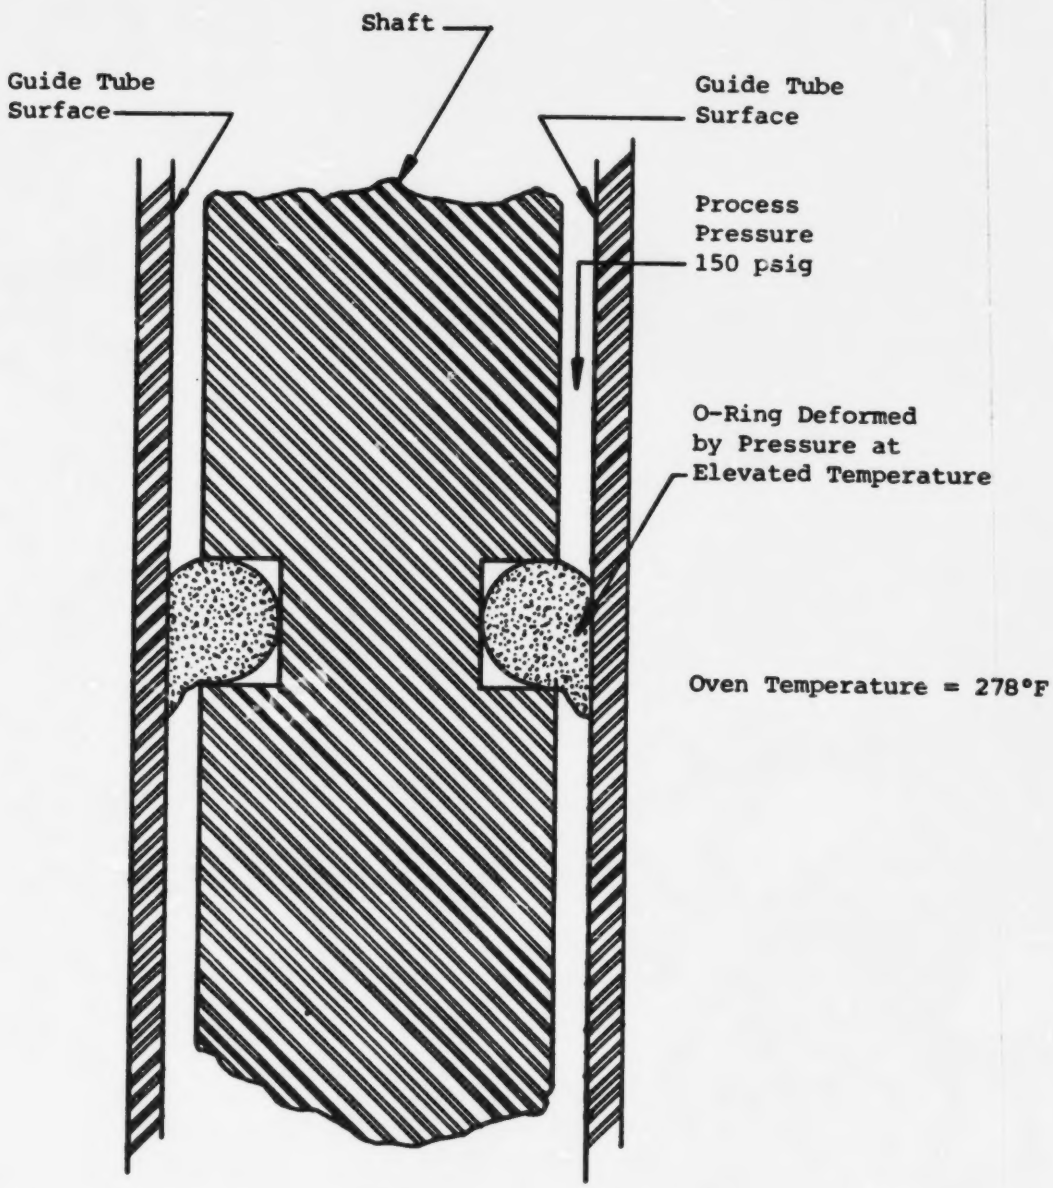
Figure 7. Hypothesized Deformation of Valcor Shaft Seal O-Ring During Accelerated Thermal Aging

Further evaluation of the failure indicated that the observed failure could have been the result of peculiarities of the accelerated thermal aging procedure which would not occur in a plant environment. Two possible causes were hypothesized.** The first hypothesis was that the physical and chemical changes of the EPDM O-ring that occurred at the elevated aging temperature and caused it to adhere to the guide tube, rather than slide in it, are different from the changes that occur under service conditions. The second hypothesis was that creep of the O-ring at the aging temperature under the stress of the process pressure far exceeded the creep that could occur under the same pressure at service temperatures. At the aging temperature (278°C [137°C]), the O-ring tends to soften; therefore, the 150-psig process pressure would tend to compress the O-ring between the shaft it rides on and the shaft guide tube (see Figure 7). When the oven temperature was reduced to room temperature with the SOV energized, the O-ring returned to a less pliable state and prevented movement of the shaft.

Because the shaft seal O-ring provides a dynamic seal during normal operation, it has several mechanical stresses acting on it. The shaft seal O-ring is under compression where it contacts the guide tube on its outer diameter and the shaft on its inside diameter. Another mechanical stress acting on the O-ring is caused by the pressure from the process medium acting downward on the upper surface of the O-ring when the solenoid coil is energized (Figure 7).

The pressure normally assists in unseating the SOV seats and starts the shaft in its downward direction when the SOV is deenergized. The second stress acting on the O-ring is related to a combination of mechanical and thermal stresses acting on it and is a possible explanation of the observed failure. At elevated temperatures, such as those used during the thermal aging simulation, the EDPM O-ring material has a tendency to soften and become more pliable, as with most rubber products. The differential pressure across the O-ring (150 psig) causes the O-ring to deform by wedging between the shaft and guide tube, such that a larger portion of the O-ring is in contact with the guide tube. If the SOV is cooled while remaining in the energized state, the deformed O-ring becomes harder and binds the shaft in its energized position.

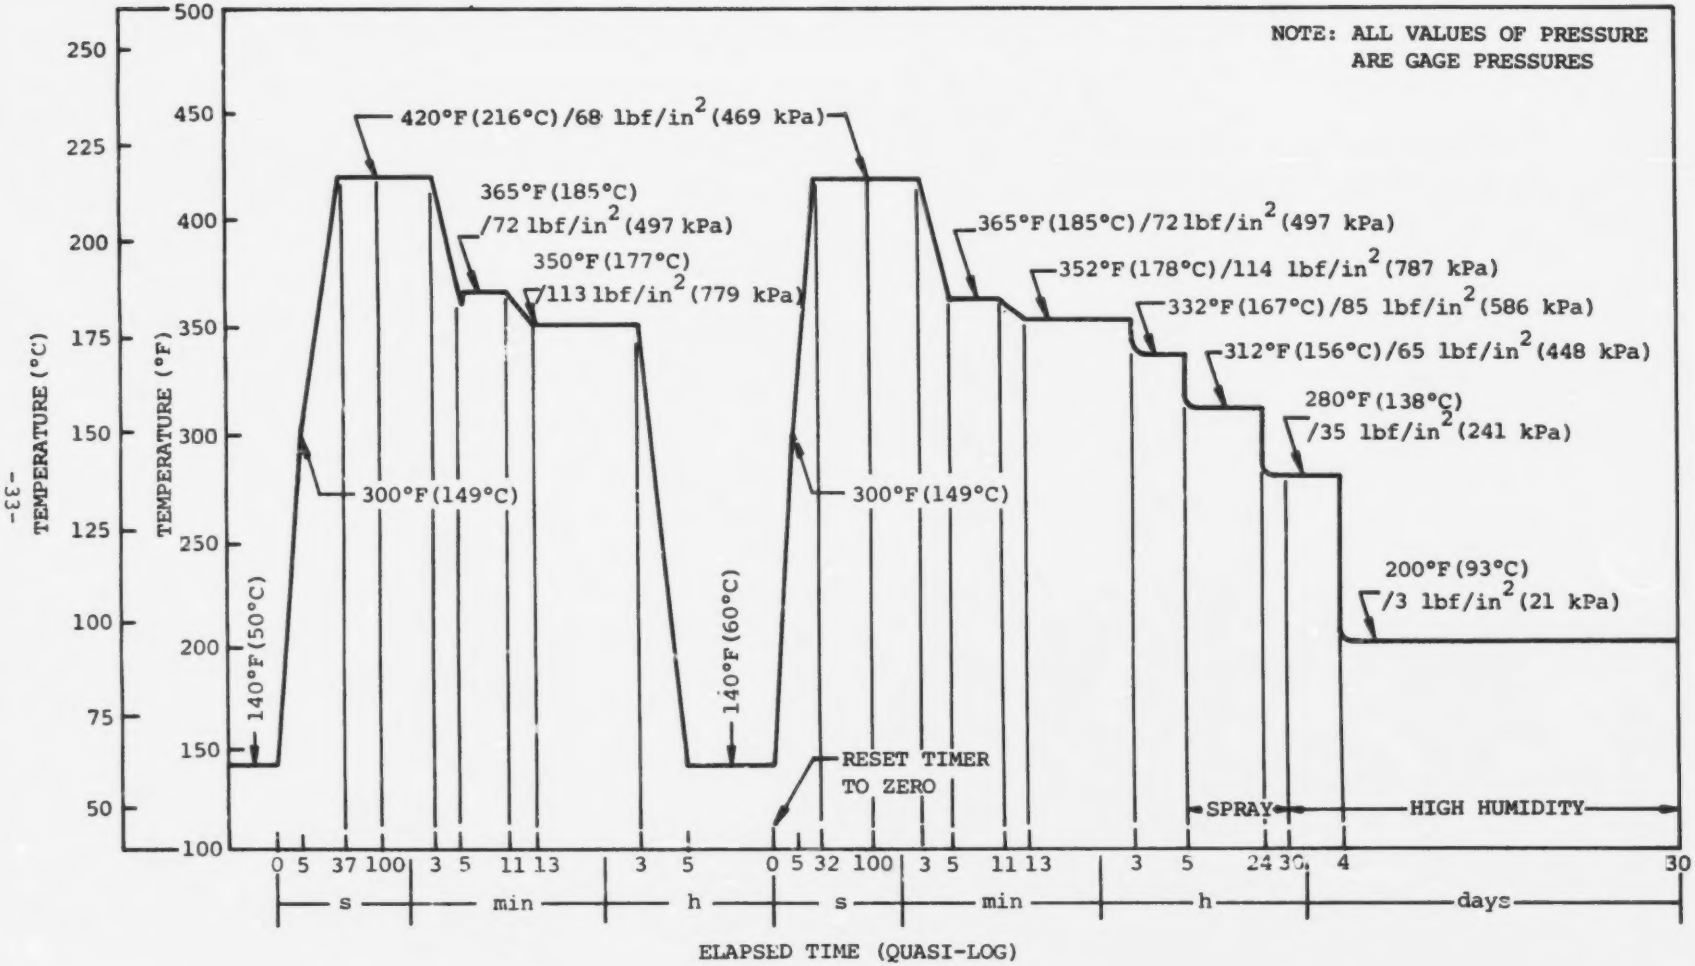
Figure 8. Actual Temperature and Pressure Profile of Simulated MSLB/LOCA Exposure

1. During the drop in temperature/pressure from 420°F (216°C)/ 68 lbf/in^2 (469 kPa) to 365°F (185°C)/68 lbf/in^2 (469 kPa) of the first transient, the temperature inadvertently decreased to a minimum of 335°F, as shown in Figure 8. The total period of this deviation was less than 2 minutes and is not considered to have a significant effect on the program. The temperature deviation is shown on an expanded time scale in Figure 9.

The actual temperature/pressures recorded throughout the first and second transients to the peak temperatures are shown in an expanded time scale in Figures 10 and 11, respectively. Aside from the minor deviation mentioned in Item 1 above, the actual temperature profile (Figure 8) was practically identical to the specified profile (Figure 6, Appendix A).

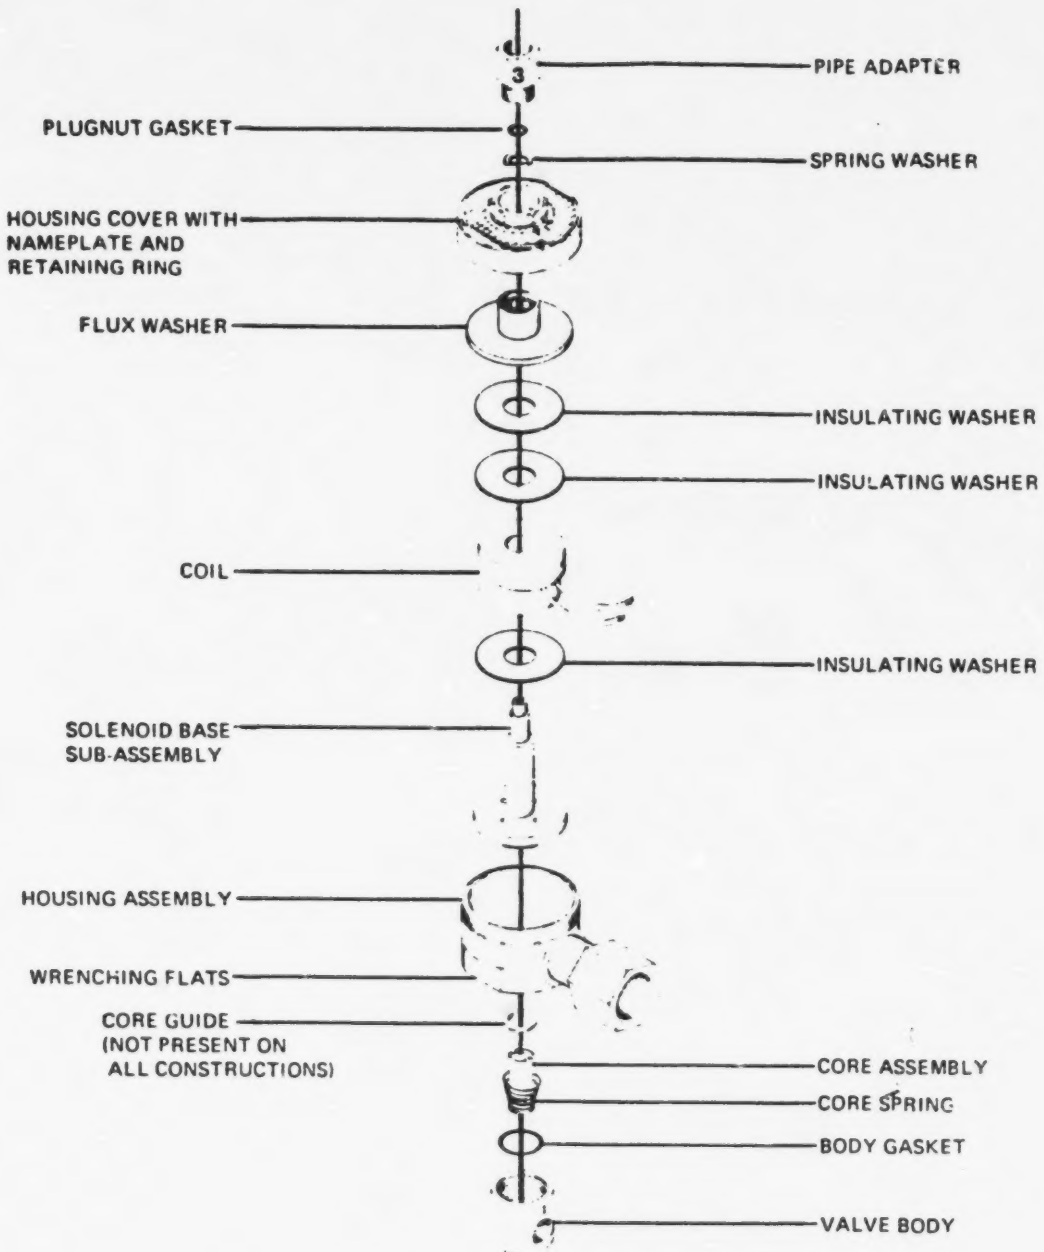
Figure 3. Exploded View of ASCO NP8314 SOV

The solenoid base O-ring provides a static seal to preclude the entrance of moisture into the solenoid coil enclosure. Complete failure of the O-ring due to thermal aging might allow entrance of moisture into the coil area during a high pressure steam exposure. Failure of the O-ring due the thermal aging is considered a low probability occurence. Intrusion of water into the coil area could result in the electrical failure of the coil; however, the fail-safe position of the SOV is normally the deenergized position. Since failure of the solenoid base O-ring coupled with subsequent coil failure would cause the SOV to go to its fail-safe position, the solenoid base O-ring is not considered the weak-link component.
